U.S. NAVAL APPLIED SCIENCE LABORATORY  
NAVAL BASE  
BROOKLYN I, NEW YORK

6  
CABLE, ELECTRO-MECHANICAL TOW TYPE AN/SQA-13  
from  
USS SAUFLEY (DE 465)  
for  
VARIABLE DEPTH SONAR APPLICATIONS.

9  
LAB PROJECT 9400-53, TECHNICAL MEMORANDUM 4

11 6 AUG 1964

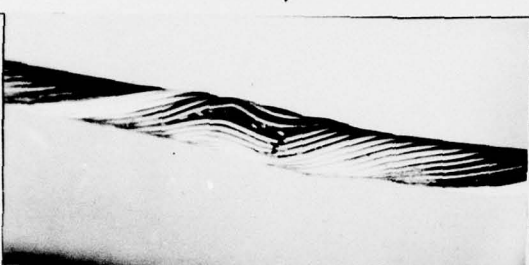
- a. Six feet from cone location- (See Fig. 1)
  - 6 Outer layer conductors broken
  - 7 Inner layer conductors brokenCenter conductor- Insulation cracked in two places at kink (knuckle). All strands broken under insulation and fatigue type rupture indicated.

OUTER LAYER CONDUCTORS - SIX BROKEN (VIEW #1)

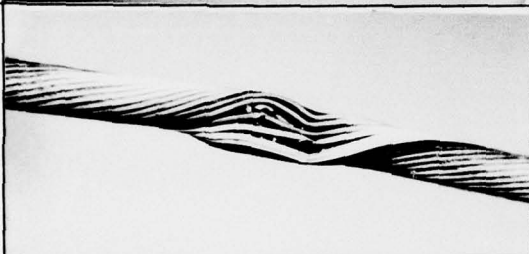
OUTER LAYER CONDUCTORS - (VIEW #2)

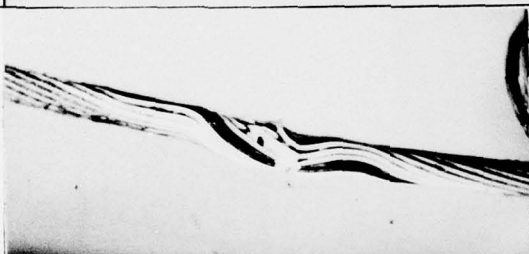
INNER LAYER CONDUCTORS - SEVEN BROKEN

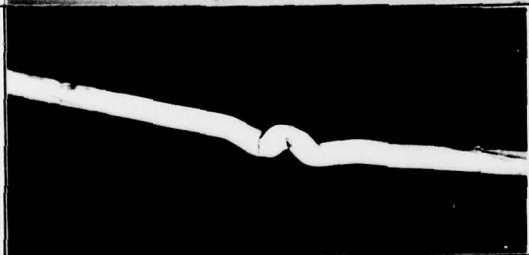
8. To form a conductor kink (knuckle), three primary conditions are required; a. The conductor must be located within a closely confined area. b. The conductor must be movable longitudinally and restricted at more than one place along its length. c. The conductor must be subjected to compression in the movable section between restricted areas. The core of electro-mechanical tow cables is designed to run over sheaves. Relative motion between conductors in a confined area must occur when the cable bends over the sheave because of the increase in circumferential distances from the sheave surface to the outer cable surface. During the latter part of vehicle retrieval the cable passes over approximately 90 degrees of the sheave surface. The center conductor is being subjected to maximum tensile

- a. Armor wires applied excessively tight during the manufacturing process.
- b. Reduction in helix diameter of the formed armor wires by excessive tension in the cable during towing operations.
- c. Excessive compression (flattening of cable) when running over the outboard sheave or drum while the cable is subjected to high tension.

CENTER CONDUCTOR - TWO INSULATION CRACKS and TWO CONDUCTOR BREAKS (ALL STRANDS)

The fatigue investigation conducted on this AN/SQA-13 cable ruptured the cable sheath because of internal pressure caused by migrating sealing compound. This demonstrates a need for an improved sealing material and more durable sheaths. Experimental VDS cable samples with an elastomeric sealer and reinforced sheaths are being procured to improve the performance of VDS cables.

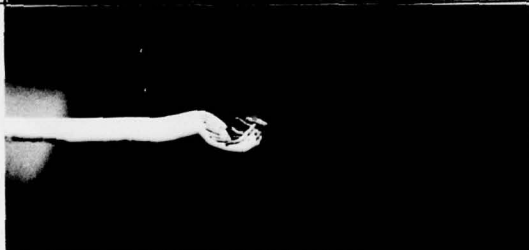
CENTER CONDUCTOR - INSULATION REMOVED
